# Monitoring wooden aircraft structures for compression failure detection

*Main objectives: to identify NDT methods for compression failure detection in spars, which are light wooden aircraft structural components*

Study conducted on behalf of the French Civil Aviation Authority (Direction Générale de l'Aviation Civile).  
DGAC study n° 06/084/MQ/FIN "Research into non-destructive compression crack detection methods for wood structures" (February 2008).  
Full version available:  
[http://www.aviation-civile.gouv.fr/html/actu\\_gd/secur2/securit\\_rap2.htm](http://www.aviation-civile.gouv.fr/html/actu_gd/secur2/securit_rap2.htm)

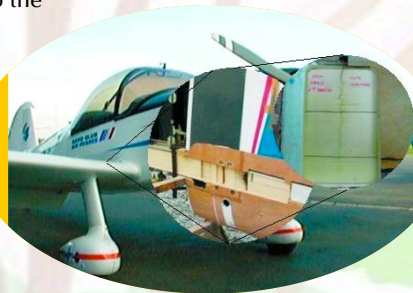
Each wing has one (or more) spars attached to the fuselage. For CAP10, the spar consists of two chords in Sitka spruce (*Picea sitchensis*) and two 5 mm thick webs in birch (*Betula pendula*) plywood. Compression failures were located on both the upper and lower wing surfaces, close to the wing/fuselage joint and extending to the landing gear attachments.

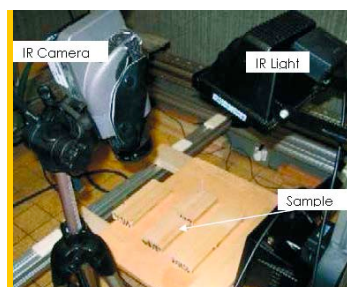
- (1) Example of response time image obtained after processing a burst of infrared images
- (2) Example of response time image obtained after processing a burst of infrared images and surface moisture penetration in wood

The defect could not be detected, irrespective of the type of excitation or the method used. This type of defect does not seem to bring about a significant modification in the thermo-physical properties of wood for its detection by infrared thermography.

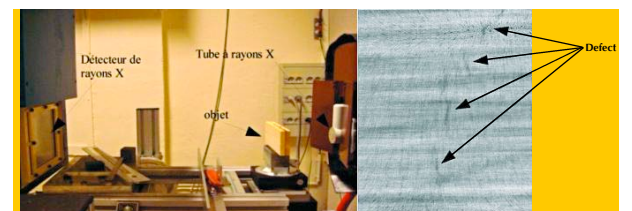
Voltage: 35 kV. Intensity: 400 µA. Acquisition time: 1 min  
Dark areas highlight compression failures. These dark areas indicate the presence of material that is denser than the surrounding material. This local densification of material at the compression crack location can be explained by buckling followed by very local fibre crushing.

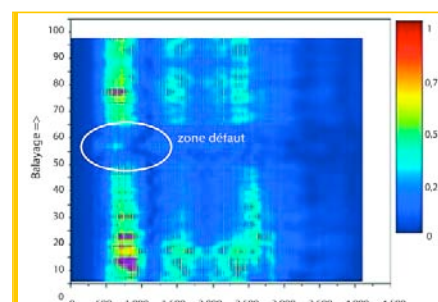
B-Scan mapping interpretation is very difficult. Out of 16 tests, 4 detections were possible without any detection on the reference specimen. None of the successful detections were related to small cracks. One large crack was not detected.
